Wear Mechanisms of Cold-Sprayed Stellite-6 During Reciprocated Dry Sliding Under Different Sliding Speeds

P. Magarò¹ · F. Furgiuele¹ · C. Maletta¹ · M. Tului² · R. J. K. Wood³

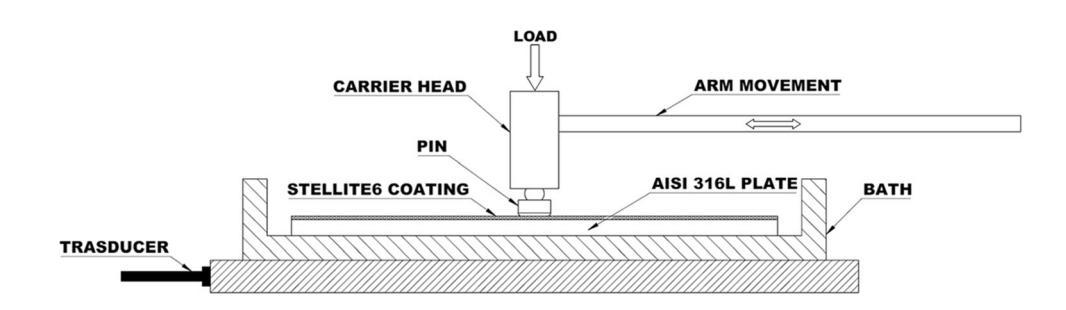
Fig. 1 Schematic depiction of the experimental equipment

The experimental tests were carried out on a reciprocating sliding test rig, i.e., TE77 (Phoenix Tribology, Berkshire, UK) in dry room condition, i.e., temperature around 25 °C and relative humidity around 40%. A schematic depiction of the test equipment is in Fig. 1.

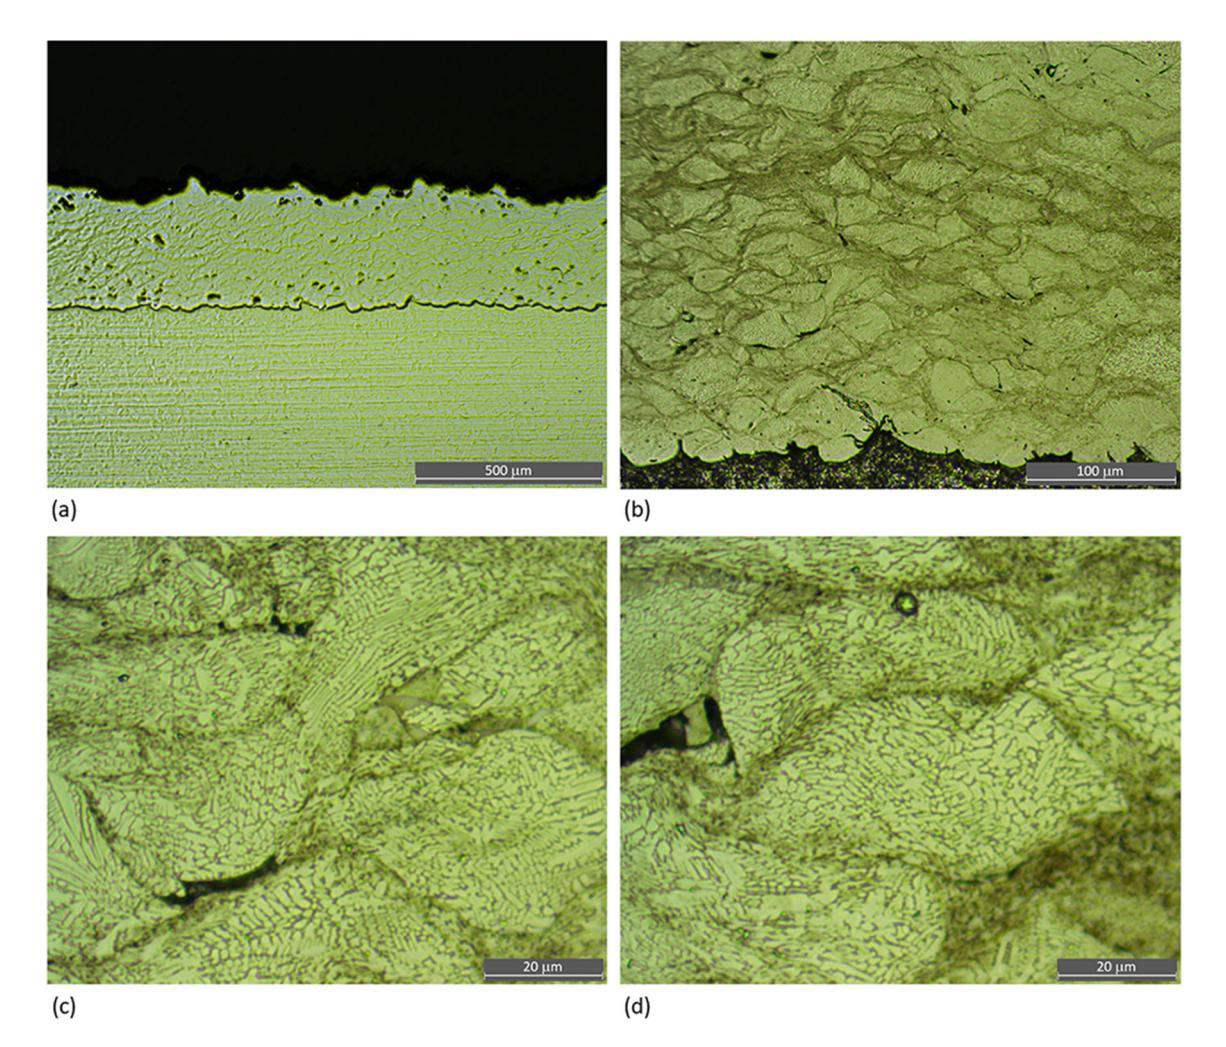
Fig. 2 Optical cross section of the coating at different magnifications: (a) & (b) low magnification level, (c) & (d) detailed features of the dendrite deformation in the particles

Figure 2 shows the cross section of Stellite-6 coatings. High compactness can be observed (see Fig. 2a) and, as explained in the previous section, the porosity content has been estimated through image analysis. In particular, it was found that the porosity content is equal to 1.9%. In Fig. 2(b) can be observed how the particle boundaries maintain their round shape and this result can be related to the resistance to deformation of the Stellite-6 powder.

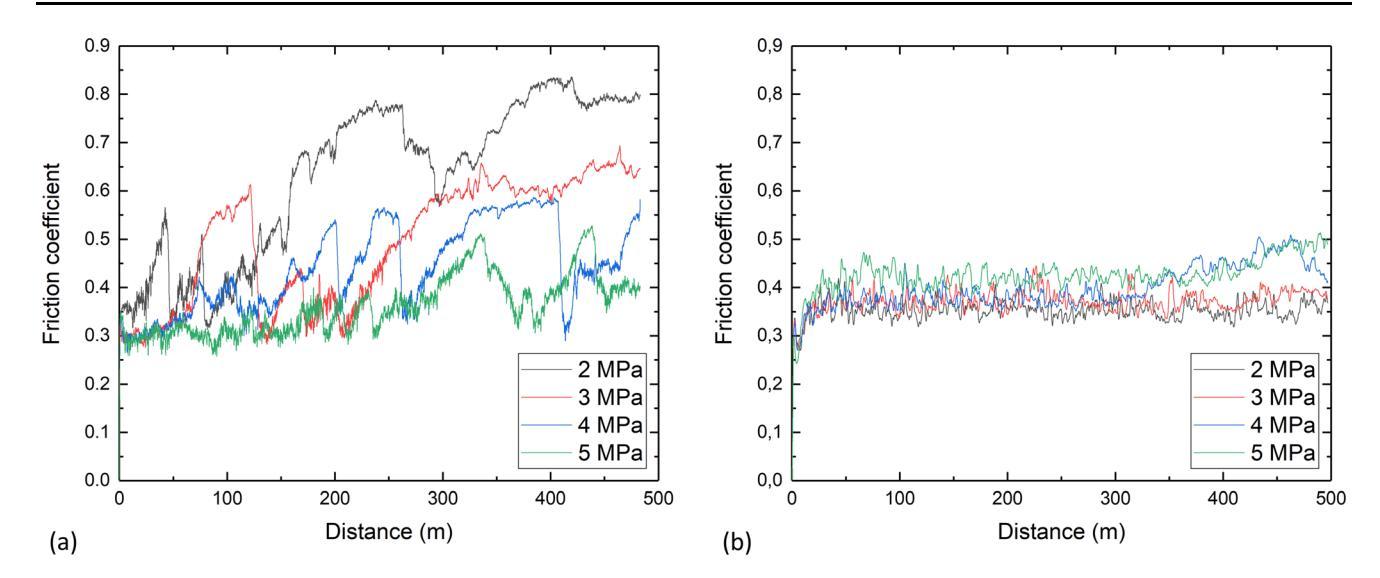
Fig. 3 Friction coefficient of Stellite-6 samples submitted to reciprocating sliding wear under different values of contact pressure and at different sliding speeds: (a) v = 0.1 m/s and (b) v = 0.5 m/s

Figure 3 reports the trends of the dynamic coefficient of friction obtained from reciprocating sliding wear

experiments as a function of the sliding distance, for each value of the contact pressure and sliding speeds (see Table 2).

Different trends are observed comparing the results at low and high sliding speeds. Nonuniform peak and valley trends were captured in the case of low speed, characterized by rapid increases followed by sudden drops, and these effects are more evident at low contact pressures (2 and 3 MPa). On the contrary, nearly constant trends were recorded at the higher sliding speed (0.5 m/s).

This observation is in agreement with the coefficient of friction results (see Fig. 3a and 4), in fact, the increase in oxidized material, as a consequence of the increasing wear debris on the worn surface, can be considered the main reason for the decreasing trend of the COF as a function of the contact pressure.

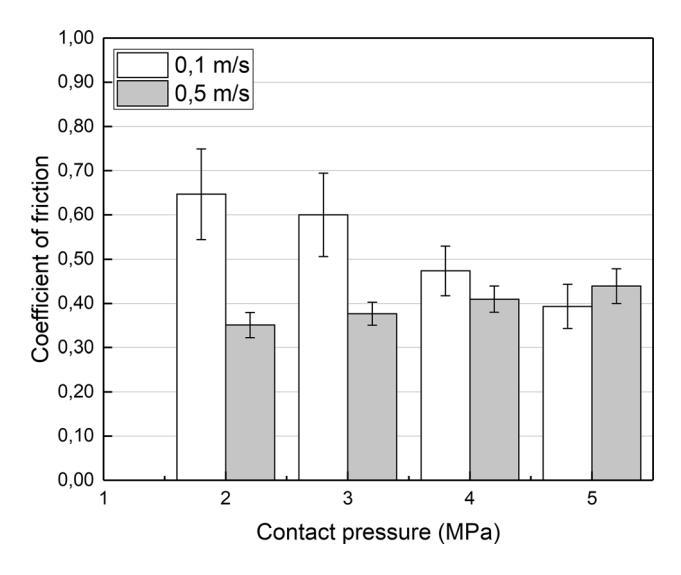
Fig. 4 Evolution of dynamic coefficient of friction as a function of contact pressure for both values of sliding speed tested

Figure 4 summarizes the average values of the frictional data, obtained through the entire sliding distance, for the different values of the contact pressure and speed reported in Table 2. Corresponding scatter bars are also shown. The coefficient of friction tends to decrease with increasing the contact pressure for low sliding speed (v = 0.1 m/s), varying in the range of 0.4-0.65. On the contrary, a slight increase with the contact pressure is observed at higher speed (v = 0.5 m/s), which is in the range of 0.35 to 0.45. Very large scatters can be observed at low speed, especially for the experiments carried out setting the contact pressure equal to 2 and 3 MPa, due to the remarkable nonuniform trend shown in Fig. 3(a). These behaviors are attributed to distinct wear mechanisms. To this aim, systematic analyses of the wear track were carried out by SEM micrographic investigations with the purpose to capture possible local effects like pull-out phenomena, abrasion, adhesion mechanisms, and crack propagation in the wear surface.

It can be summarized that in all tests carried out at low sliding speed, i.e., v = 0.1 m/s, wear mechanisms seem to be a consequence of the formation of solid debris on the worn surface resulting in pull-out phenomena, that are observable in all tested samples. This phenomenon appears to be typical after wear tests for CoCr alloys (Ref 3 and in particular for thermal-spray coatings where the splat boundaries usually represent the weak point of the system, leading to a type of fatigue wear named "grain wear" (Ref 40). This latter consists of pulled-out grains that form small flattened oxidized particles on the wear surface. This phenomenon can be considered the main reason for the reduction in the dynamic coefficient of friction as a function of the contact pressure, (see Fig. 4) since these particles act as solid lubricant.

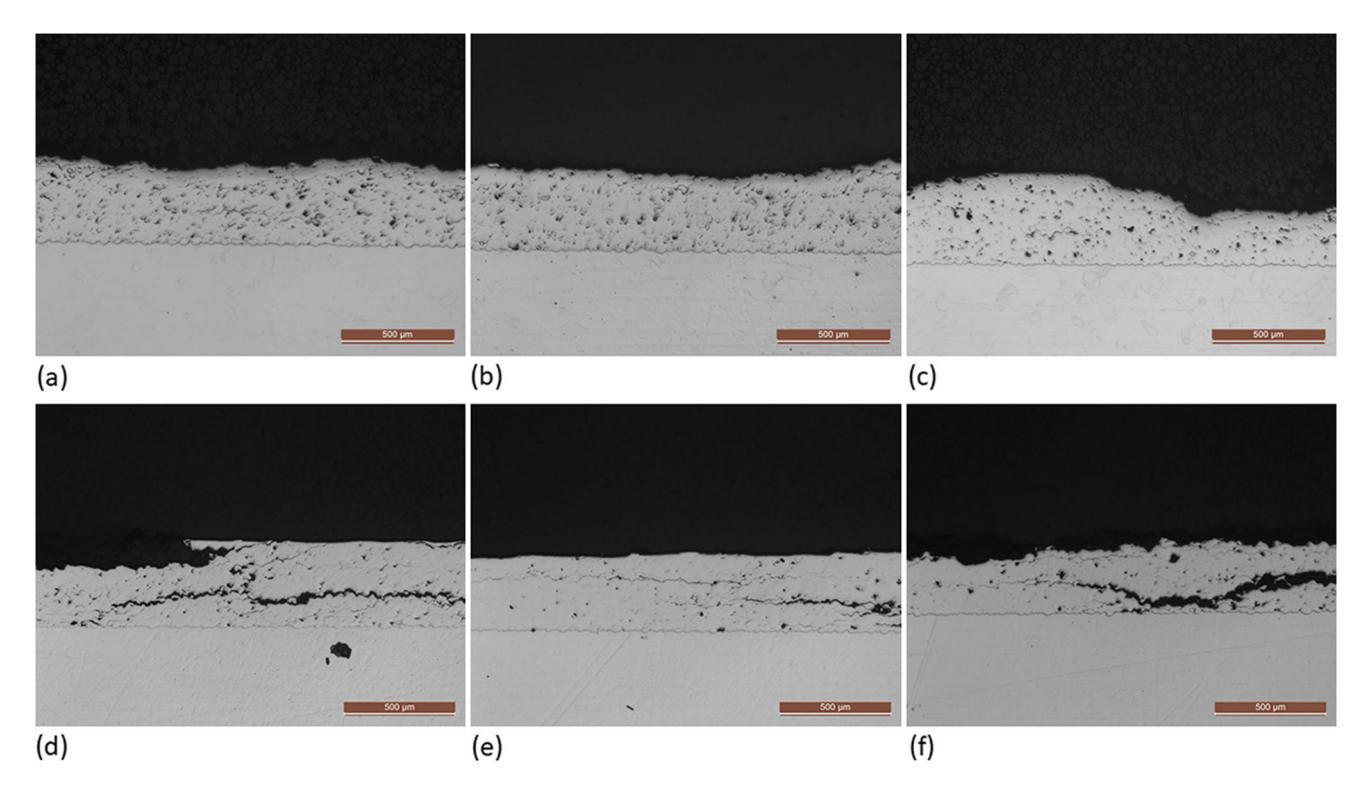
Fig. 5 Representative light micrographs of the samples cross sections for different levels of contact pressure and sliding speed: (a) 2 MPa-0.1 m/s, (b) 3 MPa-0.1 m/s, (c) 4 MPa-0.1 m/s, (d) 2 MPa-0.5 m/s, (e) 3 MPa-0.5 m/s, (f) 4 MPa-0.5 m/s

Figure 5 shows representative cross sections, perpendicular to the sliding direction, of worn samples. Micrograph images of the samples tested at v = 0.1 m/s do not show subsuperficial cracks along with the thickness of the

coating (see Fig. 5a, b and c). On the contrary, subsurface cracks are formed during tests carried out at high speed, i.e., v = 0.5 m/s (see Fig. 5d, e, and f), suggesting that wear mechanisms are mainly affected by the sliding speed. Nevertheless, the involved wear mechanisms will be better addressed in the following sections, where SEM micrographs of the wear surface are reported and discussed.

speed conditions, further suggesting that material has been highly strained and smeared across the surface covering the underlying sprayed material. A similar phenomenon, considered as "*shear tongues*", can be seen in laser-clad stellites by Persson (Ref 4. Debris observed throughout all high-speed tests appears to be "plate-like" and consists of smaller broken-up portions of debris that are characterized by a diameter no larger than 10 μ m characterized by strained material, displaced across the surface as a consequence of the peeling-off or adhesion of plate-like wear particles. These latter seem to be the consequence of subsurface crack nucleation, observable in the micrograph images of the cross section (see Fig. 5d, e, f), leading to the formation of platelets.

The nano-indentation measurements carried out on the coatings tested at high speed, i.e., v = 0.5 m/s, are pointed out in Fig. 13. The obtained results show a reduction in the stiffness (Fig. 13a) and a similar trend in the hardness response (Fig. 13b) as a function of the contact pressure. In addition, it can be noted that this phenomenon is more pronounced in the zones closer to the contact surface. The trends in the hardness can be considered a direct consequence of the high temperature reached during the highspeed tests (v = 0.5 m/s). High temperature, in fact, often implies noticeable modifications in the coating microstructure so, this behavior can be related to the grain size evolution of the microstructure. In fact, due to the Hall-Petch effect (Ref 43, 44), the hardness of materials tends to increase with grain refinement as a consequence of enhanced dislocation pile-up at grain boundaries. It can be concluded that the decreasing trend observed in the nanohardness response could be considered a consequence of grain growth phenomena. Moreover, the observed reduction in the hardness values along the thickness can be also related to the increased presence of cracks inside the coating, clearly observable in Fig. 5(d), (f) and (f).

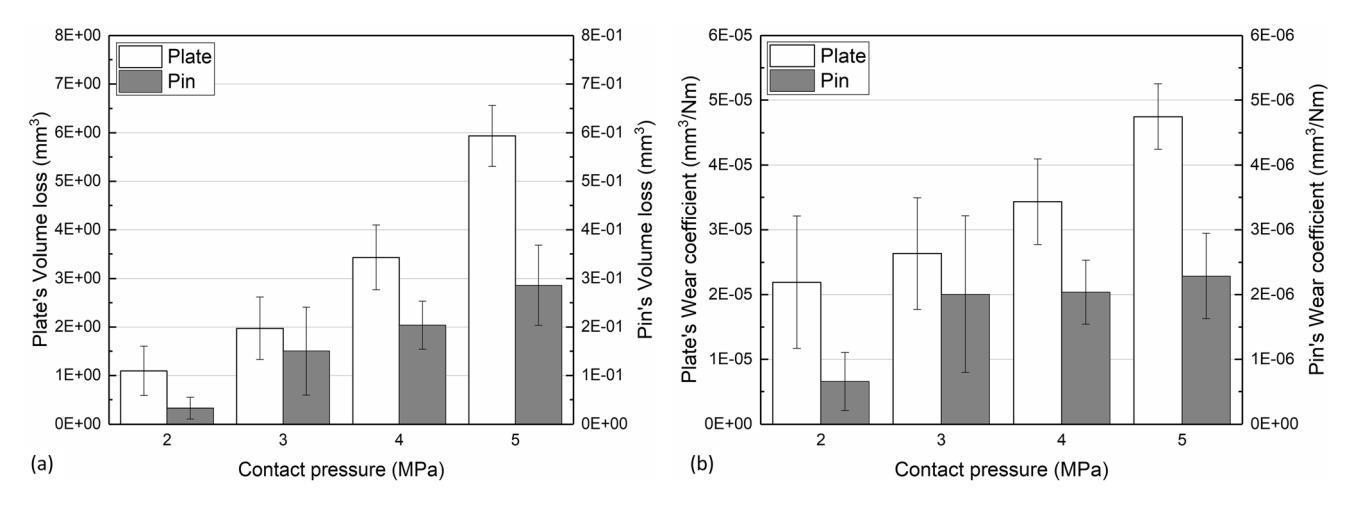
Fig. 6 Volume loss and wear coefficient vs. contact pressure plots for 0.1 m/s

Figure 6(a) and (b) reports the evolution of volume loss and wear coefficient as a function of the contact pressure. The volume loss experienced corresponds to a wear coefficient of the order of 2×10^{-5} - 5×10^{-5} mm³/Nm and

6.5×10^{-7} -2.5 $\times 10^{-6}$ mm³/Nm for the plate and pin, respectively. It is interesting to note how the obtained results show a nonlinear trend in the volume loss, and so in a non-constant trend of the wear coefficient. Therefore this material system is not in agreement with Archard's model in its wear behavior and thus not Archard-like according to Eq (1). Both values tend to increase increasing the contact pressure as a consequence of the higher density of pull-out phenomena, and as confirmed by the microscopic observation that will be further discussed below.

The highest value of the contact pressure, in fact, leads to the greatest value of both volume loss and wear coefficient as a direct consequence of the increased pull-out phenomena and grain wear. A confirmation of the occurrence of pull-out phenomena during the sliding at low speed can be found in the evolution of the dynamic friction coefficient as a function of the sliding distance for all values of the contact pressure as shown in Fig. 3(a). The sudden variations of friction coefficient, observed during the low-speed tests, correspond with delamination ignition and consequent detachment of splats that tend to form a tribo-film consisting reasonably of oxidized wear debris. This phenomenon is observable on the wear track as displaced material, and acts as solid lubricant. Therefore, the dynamic friction coefficient tends to decrease by increasing the contact pressure as shown in Fig. 4. Due to the significant increase in both volume loss and wear coefficient with the contact pressure (see Fig. 6), it is reasonable to assume that the amount of tribo-film on the wear track increase with the contact pressure.

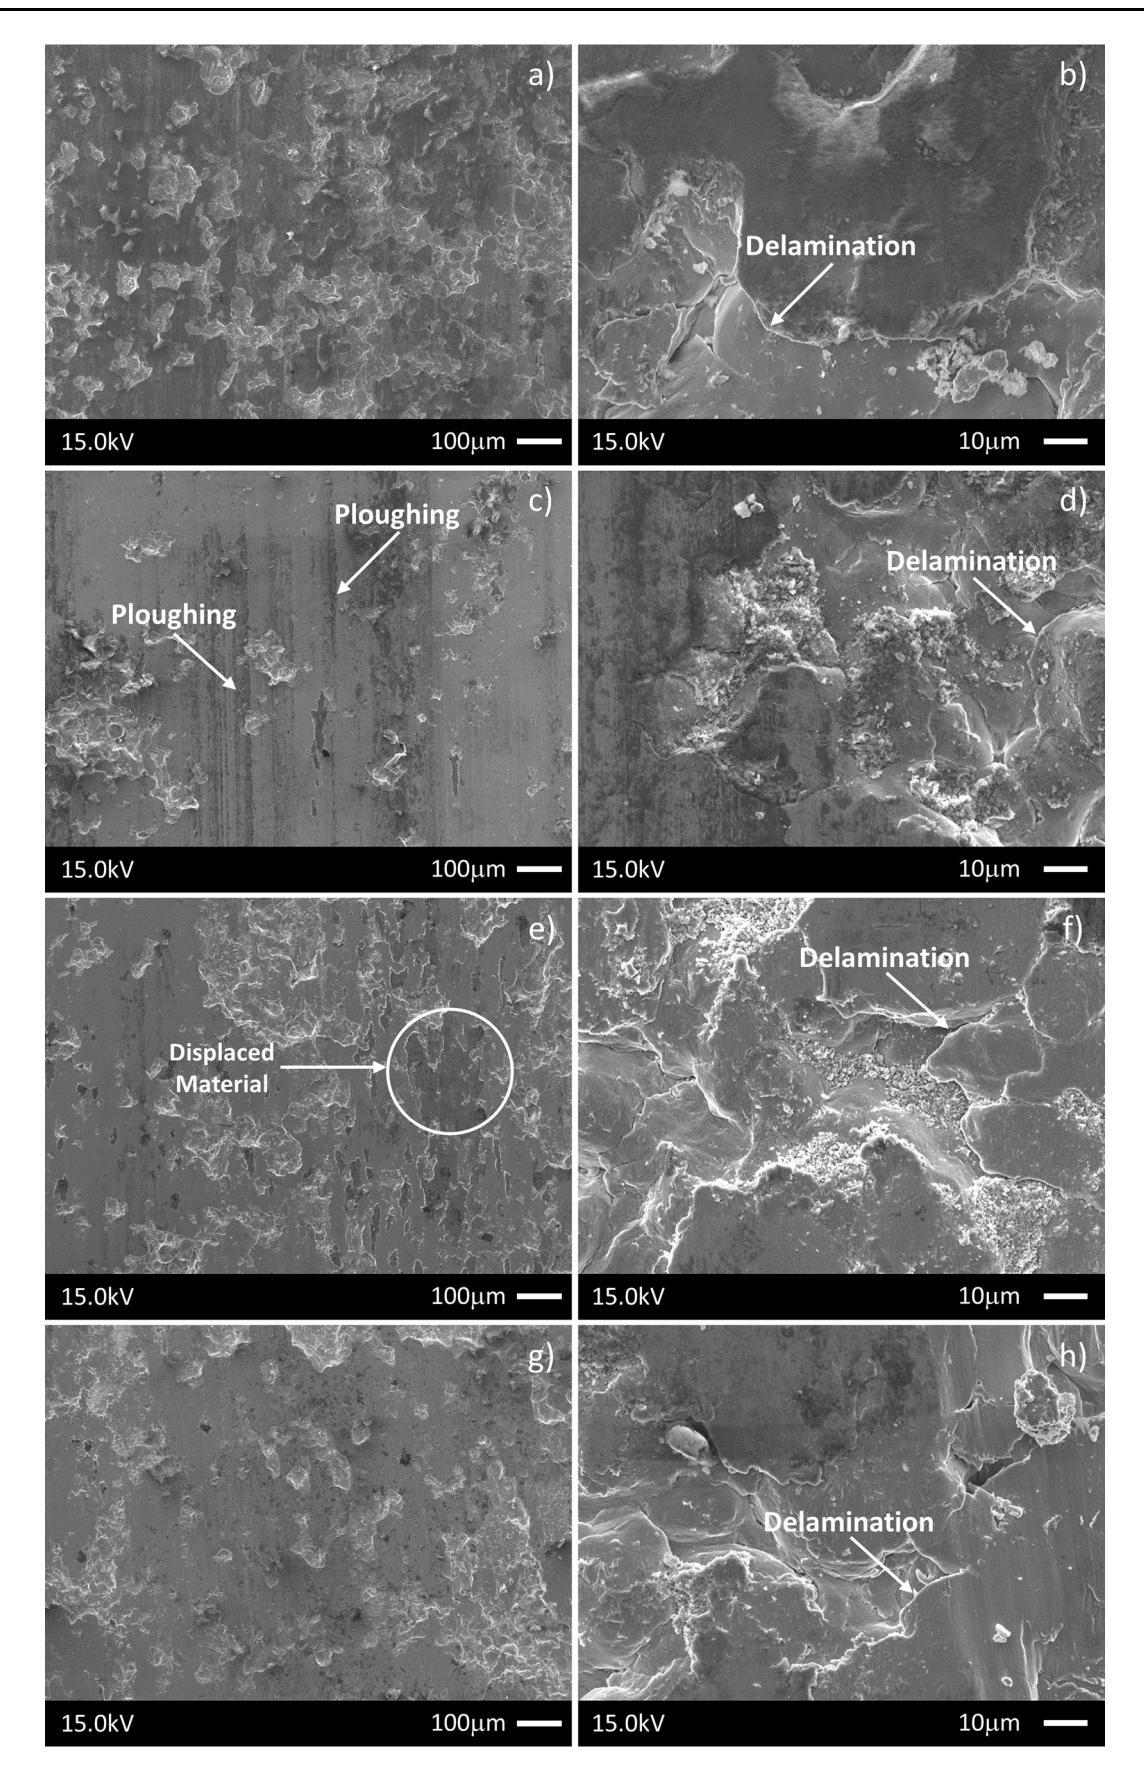
Fig. 8 Representative SEM micrograph of the wear surface on the pin at the sliding speed

v = 0.1 m/s under different

(d) p = 5 MPa

contact pressure: (a) p = 2 MPa,

(b) p = 3 MPa, (c) p = 4 MPa,

Fig. 7 Representative SEM micrograph of the wear surface on the samples tested at the sliding speed v = 0.1 m/s under different contact pressure: (a) and (b) p = 2 MPa, (c) and (d) p = 3 MPa, (e) and (f) p = 4 MPa, (g) and (h) p = 5 MPa

Figure 7 shows post-wear SEM micrographs of the worn surface of samples tested at increasing values of the contact pressure, from 2 to 5 MPa. The wear mechanism seems to be mainly abrasive throughout all experiments with evidence of pull-out phenomena. This assumption seems to be confirmed by the micrographic observations of the cross section of the samples (see Fig. 5a, b and c) that do not show subsuperficial cracks confirming the formation of pulled-out debris while running tests.

In the case of low sliding speed delamination phenomena were also observed, as the worn surface appears to be characterized by visible sharp edges as a consequence of the abrasive effects. The higher magnification SEM images revealed that delamination occurred mainly on the intersplat boundaries (see Fig. 7b, d, f, and h), suggesting that this latter is the weak point of the coating. The sudden variations of COF (see Fig. 3a) during the tests correspond, in fact, with the delamination initiation and with the consequent pull-out phenomena occurring in the wear track. In addition, plowing can be observed on the worn surface and can be considered the main wear mechanism in those regions that are not affected by delamination and pull-out phenomena. In addition, evidence of strained and displaced material across the wear surface is seen in all tests, therefore the creation of tribofilm can be expected on the wear surface.

Figure 8 shows the post-wear SEM micrographs, from 2 to 5 MPa, for the pins' wear surface. Deformed material can be identified as trapped wear debris. These latter are visible on the worn surface and appear deformed, transferred, and adhered to the worn surface.

In addition, in Fig. 8(d) it is possible to observe how the material is displaced on the worn surface of the pin. This type of deformation is characteristic of the tests carried out setting the contact pressure equal to 5 MPa.

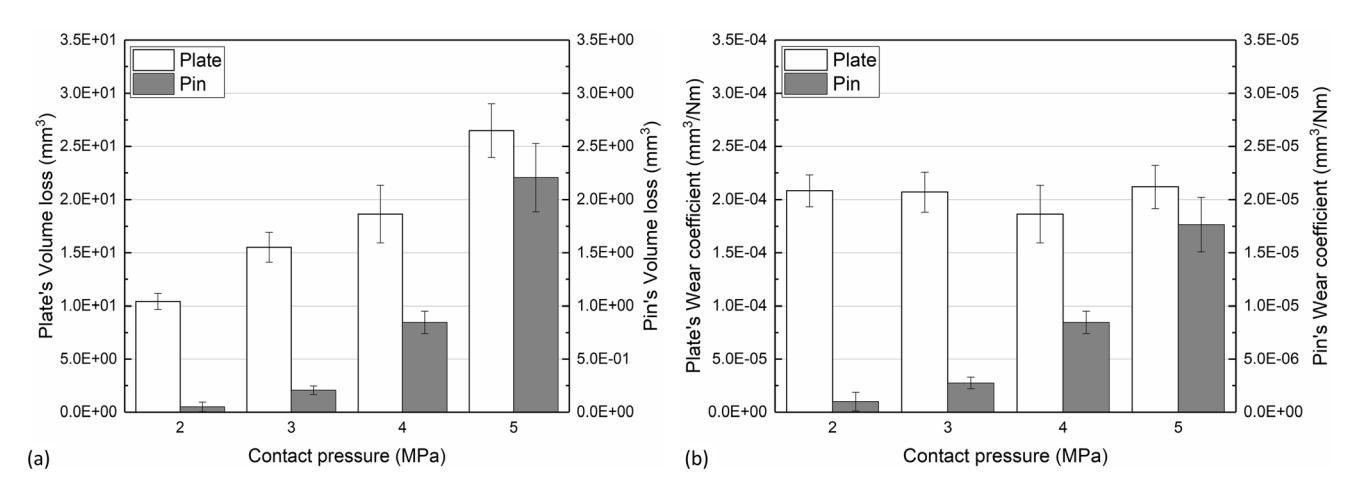
Fig. 9 Volume loss and wear coefficient vs. contact pressure plots for 0.5 m/s

Figure 9 shows the evolution of volume loss and wear coefficient, as a function of the contact pressure, for the high sliding speed tests (v = 0.5 m/s). In this case, a linear trend can be seen for the volume loss (see Fig. 9a) and therefore an almost constant wear coefficient trend, as shown in Fig. 9(b). In addition, the dynamic friction coefficient at p = 2 MPa is the lowest among all the experiments, as shown in Fig. 4. This latter result can be attributed to two mechanisms: (i) the higher temperatures reached in the contact zone as a consequence of the higher value of the sliding speed; (ii) limited adhesion phenomena as a consequence of the low contact pressure that leave the place to the presence of oxidized material on the wear track that tends to form a tribo-film (Ref 4) with a reduction in the friction coefficient during the test.

In particular, the obtained results show that the wear coefficient is in the order of $\sim 2 \times 10^{-4}$ mm³/Nm and $2.75 \times 10^{-6}-2 \times 10^{-5}$ mm³/Nm for the plate and pin, respectively, which are by an order of magnitude greater than literature data for the same testing conditions reported by Cross et al. (Ref 39) for a HIPed cobalt-chromium alloy. The presence of internal porosity, in fact, and the consequent crack initiation and propagation are responsible for the severe wear mechanisms discussed in this section.

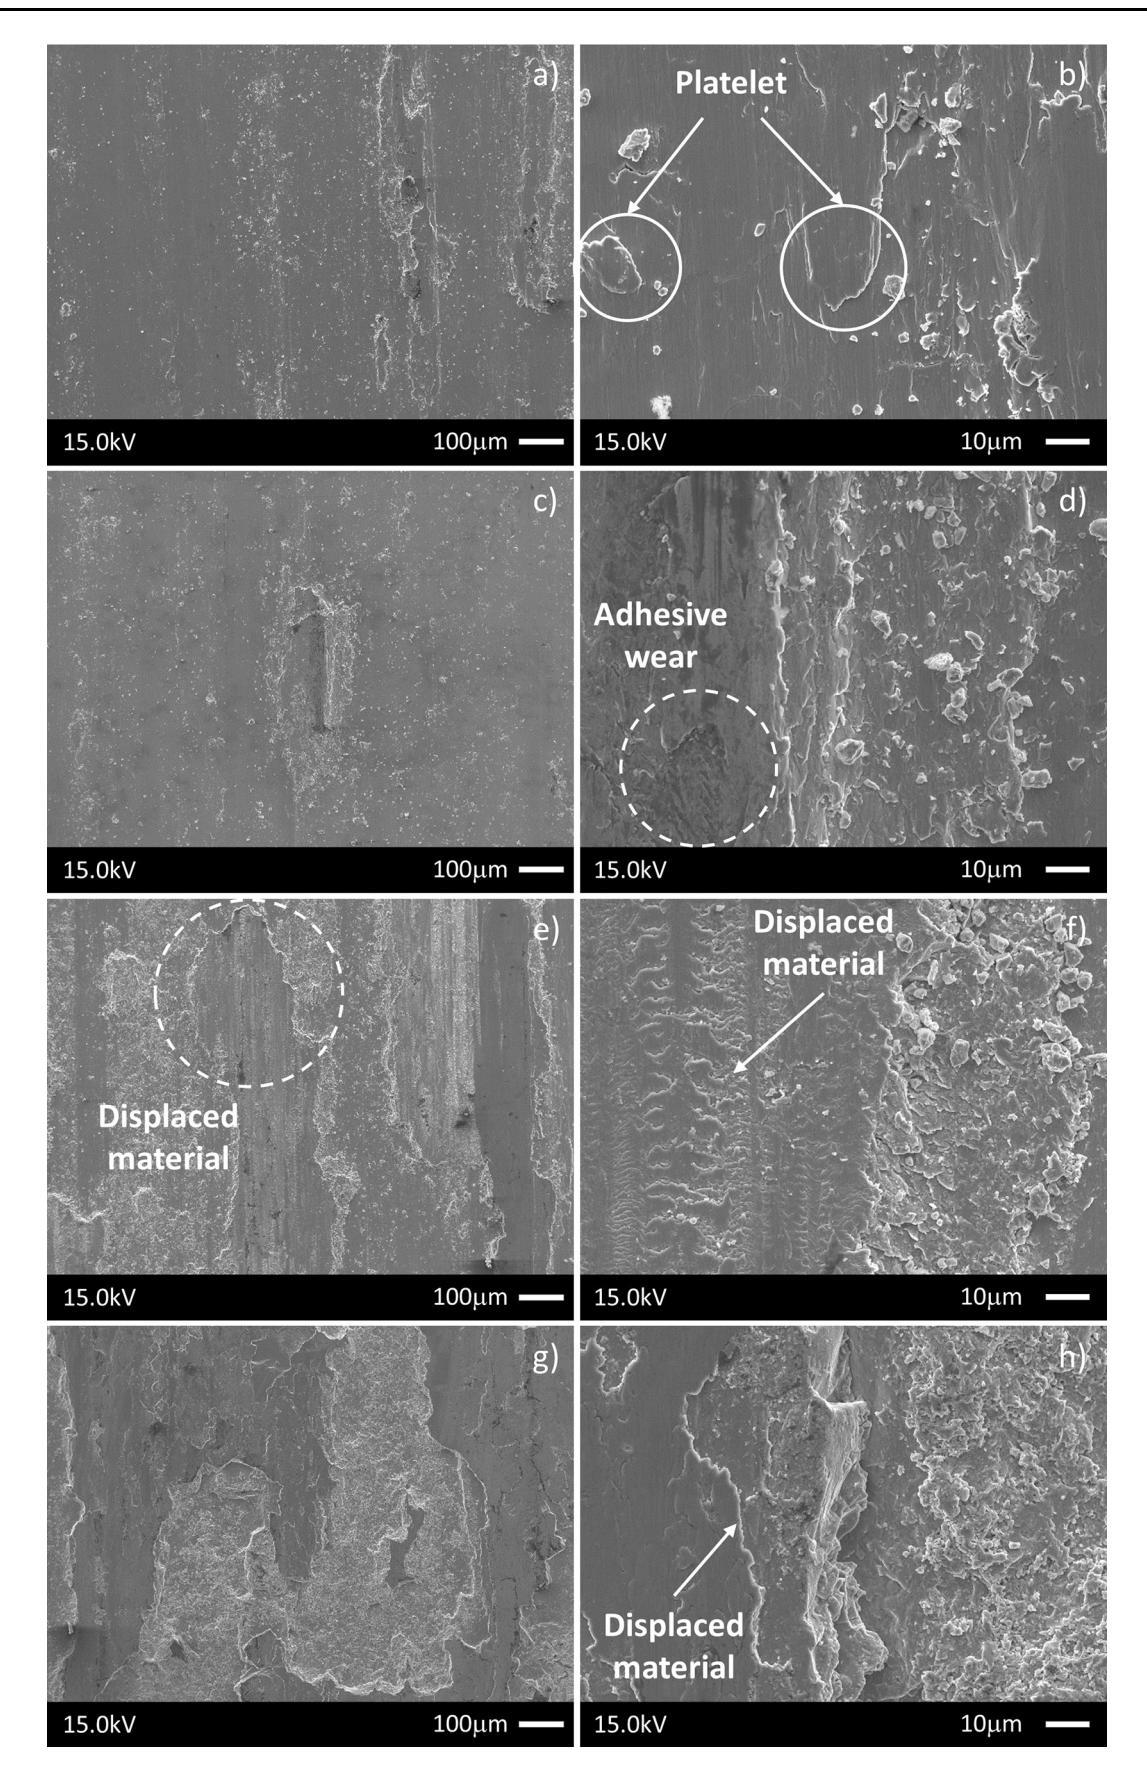
Fig. 10 Representative SEM micrographs of the wear surface of the samples tested at the sliding speed v = 0.5 m/s under different contact pressure: (a) and (b) p = 2 MPa, (c) and (d) p = 3 MPa, (e) and (f) p = 4 MPa, (g) and (h) p = 5 MPa

Figure 10 reports the representative post-wear micrographs of the wear surfaces for the samples tested at

v = 0.5 m/s and under increasing values of the contact pressure, from 2 to 5 MPa. Adhesive wear can be seen in all tested samples. Formation of platelet can be seen on the worn surface, in particular for those samples tested under 2 MPa of the contact pressure. This latter can be considered peeling from the surface, as seen in Fig. 10(b). Moreover, material appears adhered and pushed on the wear track, with evidence of pressed and displaced material across the surface, as can be seen in Fig. 10(d), (f), and (h). In addition, in Fig. 10 (h) it is clearly visible the presence of ridges that are due to the displacement of material.

The high-magnification images show the presence of debris on the wear surface that tend to increase increasing the contact pressure. The below layers of the coating cannot be seen either at high magnifications, as can be observed in the wear surface of the samples tested in low-

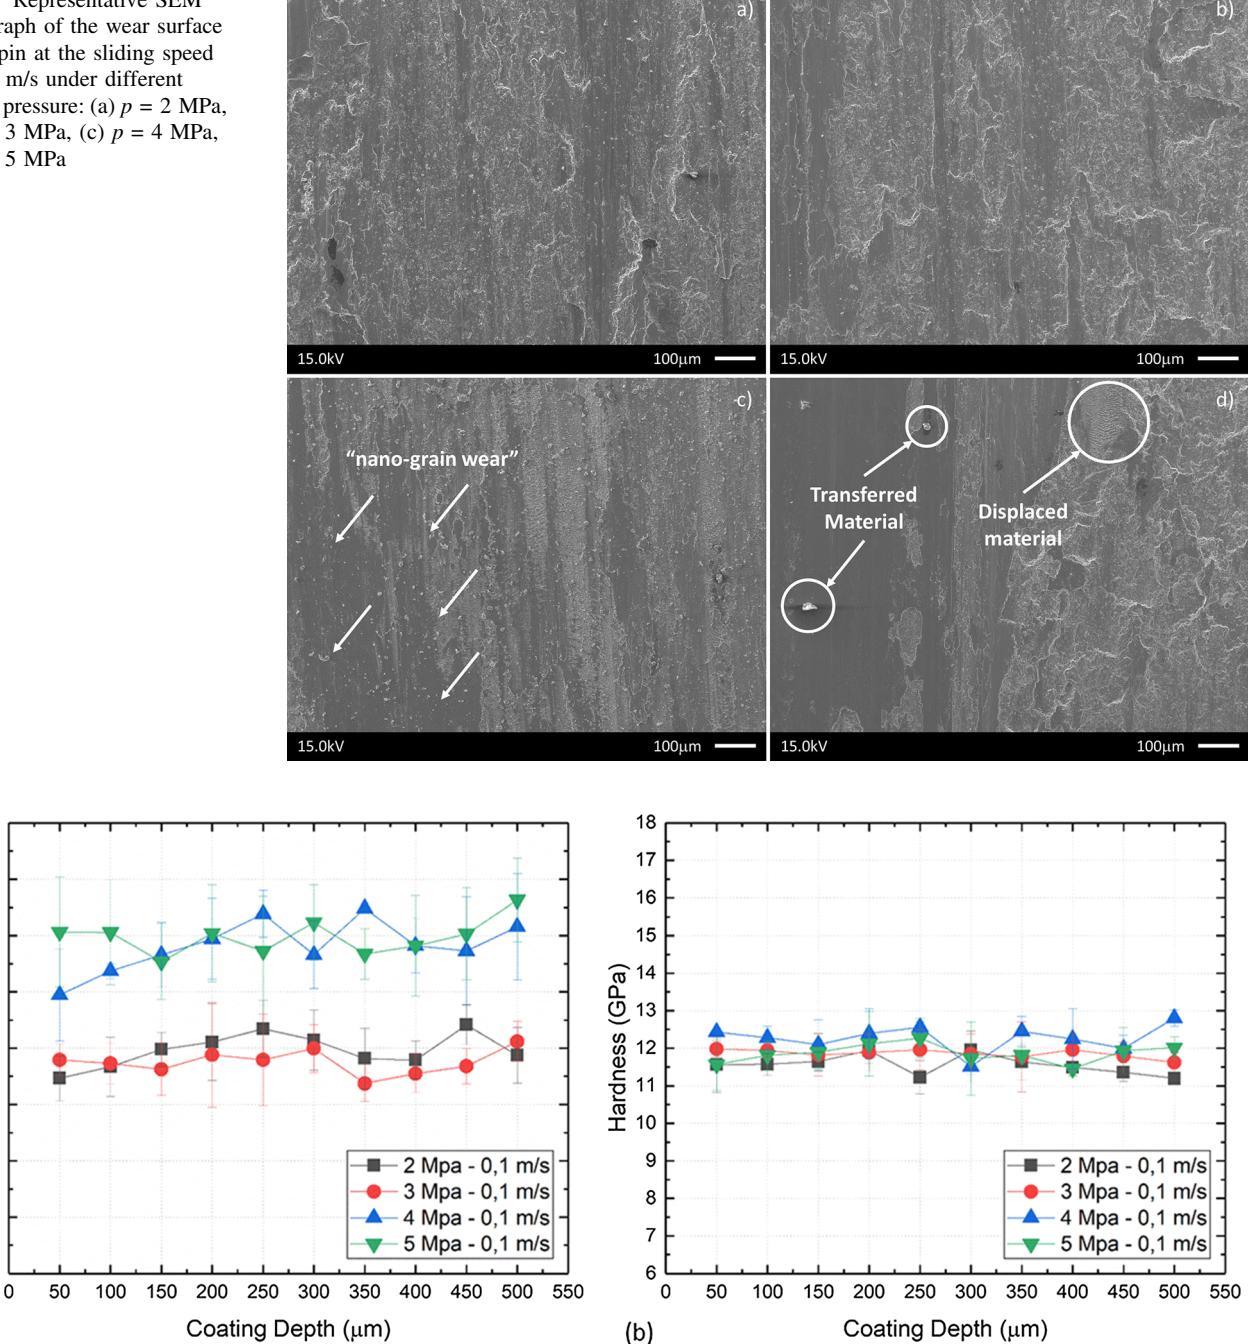
Fig. 12 Plot of the nano-indentation results for reduced elastic modulus and hardness vs. depth for low-speed tests

The nano-indentation measurements carried out on the cross section of samples tested in low sliding speed conditions ($\nu = 0.1$ m/s) are reported in Fig. 12. An almost flat trend for both elastic and hardness responses can be observed. However reduced Young's modulus, shown in Fig. 12(a), is lower in the samples tested at a contact pressure of 2 and 3 MPa than in the case of 4 and 5 MPa, with average values of around 218 GPa and 238 GPa, respectively. On the other hand, a different trend was observed in the hardness response, as highlighted in Fig. 12(b), where the measured hardness values seem to be basically unaffected by the contract pressure.

It is interesting to note that reduced Young's modulus and hardness, measured on samples tested at 2 and 3 MPa, are extremely close to those measured on the "as-sprayed" coatings, i.e., 212 GPa and 10.2 GPa, respectively, as reported in a previous paper by the authors [37]. The trend observed for stiffness data can be explained by considering that the higher values of the contact pressure tend to close any possible subsuperficial defects below the worn surface. In the previous section, in fact, it was shown that the cross section of coatings tested at low speed is not characterized by the presence of longitudinal cracks unlike those tested at high speed (see Fig. 5).

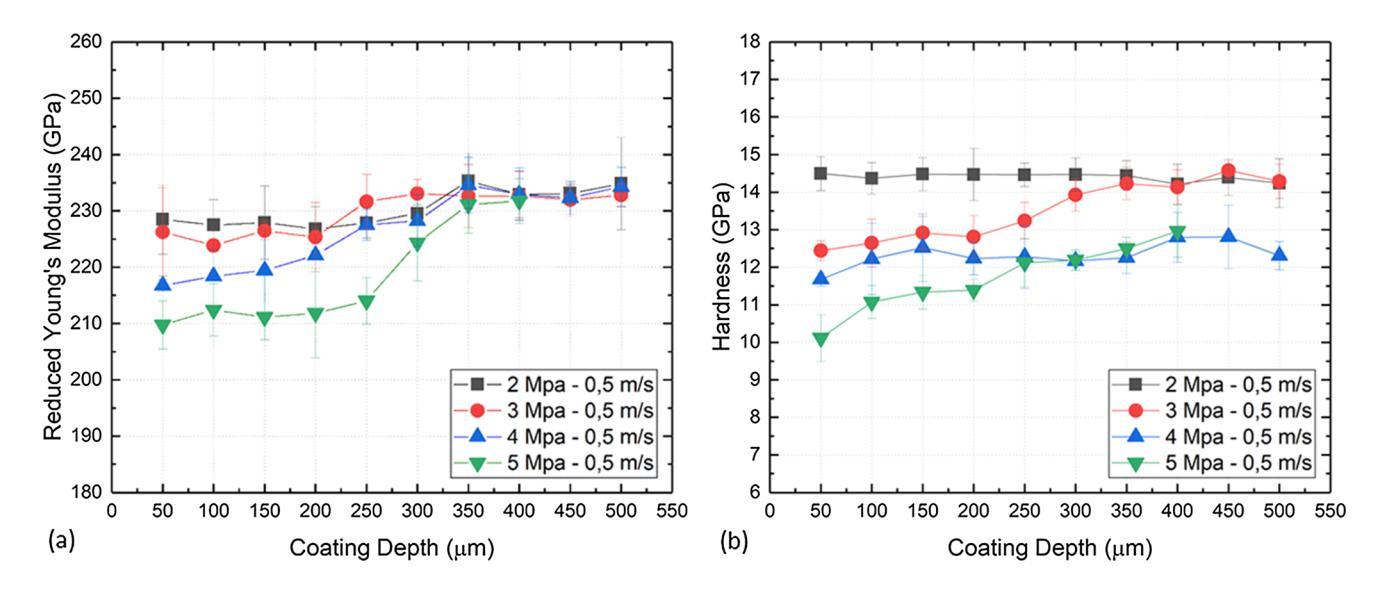
Fig. 13 Plot of the nano-indentation results for reduced elastic modulus and hardness vs. depth for high-speed tests

Regarding the elastic response, the marked reduction in the reduced Young's modulus can be explained by taking into account the presence of cracks and detached material below the surface occurring during the sliding. In fact, a reduction in the elastic modulus is mainly due to the allowed rigid motions of debonded particles from the coatings during the indentation, and this phenomenon tends to increase by increasing the contact pressure between pin and sample.
